# Basic Detail Report

## Damage to USS Intrepid's Rudder Post Casting

March 23, 1944

USS Intrepid (CV/CVA/CVS-11)

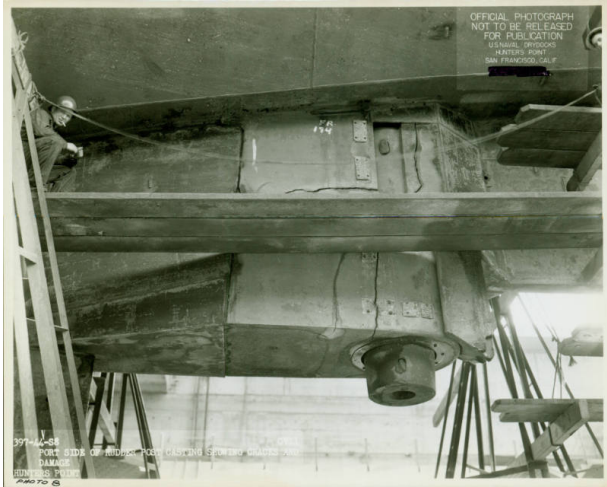
Photograph, Black and white; Official horizontal image of USS Intrepid in dry dock to repair torpedo damage. This view shows the area where Intrepid's rudder is usually attached to the ship, although the rudder itself has been removed and does not appear in the image. The rudder post housing is cracked. There is a man in upper left corner wearing a helmet with a cigarette in his mouth looking at the camera. Caption on top right of image reads "Official Photograph // Not to be Released // for Publication // U.S. Naval Drydocks // Hunters Point // San Francisco, Calif." Caption on bottom left of image reads "397-44-S8 CV11 // Port side of rudder post casting showing cracks and // damage // Hunters Point 23 March 1944".
