# Basic Detail Report

## Motor Control Room on USS Intrepid during Repairs

March 28, 1944

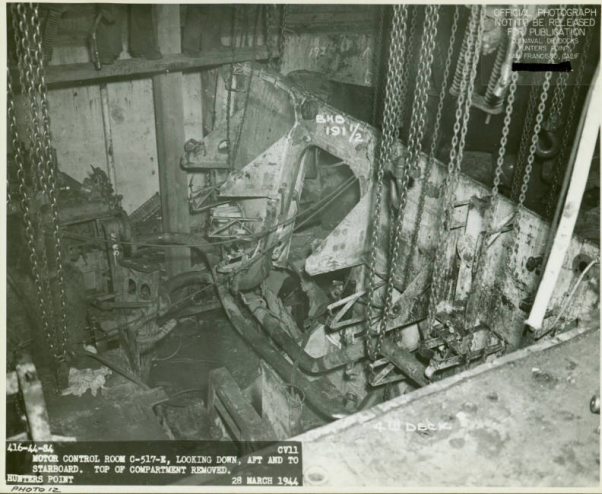
Photograph, Black and white; Official horizontal image of the motor control room (C-517-E) on USS Intrepid in dry dock to repair torpedo damage. The top of the compartment has been removed and repair work is in progress. There are large pipes in the bottom of the compartment, and chains hang down from the overhead. 4th deck is marked on the image. Caption on top right of image reads "Official Photograph // Not to be Released // for Publication // U.S. Naval Drydocks // Hunters Point // San Francisco, Calif." Caption on bottom left of image reads "416-44-54 CV11 // Motor control room C-517-E, looking down, aft and to // starboard. Top of compartment removed. // Hunters Point 28 March 1944".
