Damage and Repairs to Starboard Side Void Compartment on USS Intrepid

March 28, 1944

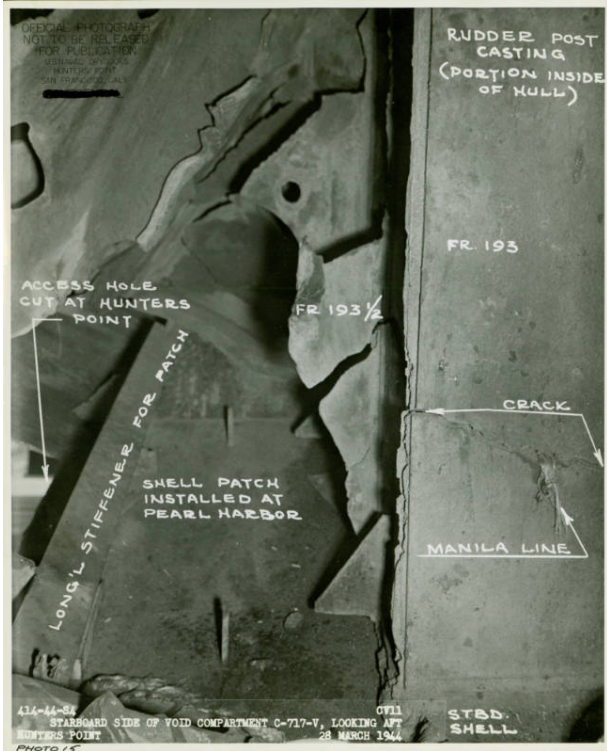
Photograph, Black and white; Official horizontal image of the damage on the starboard side of void compartment (C-717-V) on USS Intrepid. Intrepid is in dry dock to repair torpedo damage. Parts of the void compartment are labeled in white marker indicating where patches and damaged are located. Labeled items include the rudder post casting, shell patch and an access hole.

Caption on top right of image reads "Official Photograph // Not to be Released // for Publication // U.S. Naval Drydocks // Hunters Point // San Francisco, Calif." Caption on bottom left of image reads "414-44-S4 CV11 // Starboard side of void compartment C-717-V, looking aft // Hunters Point 28 March 1944".
